Remediation of a NORM contaminated site in Lower - Austria

Michael Dauke and Christian Katzberger

Austrian Agency for Health and Food Safety -
Competence Centre Radiation Protection and Radiochemistry
Spargelfeldstraße 191, A-1220 Vienna

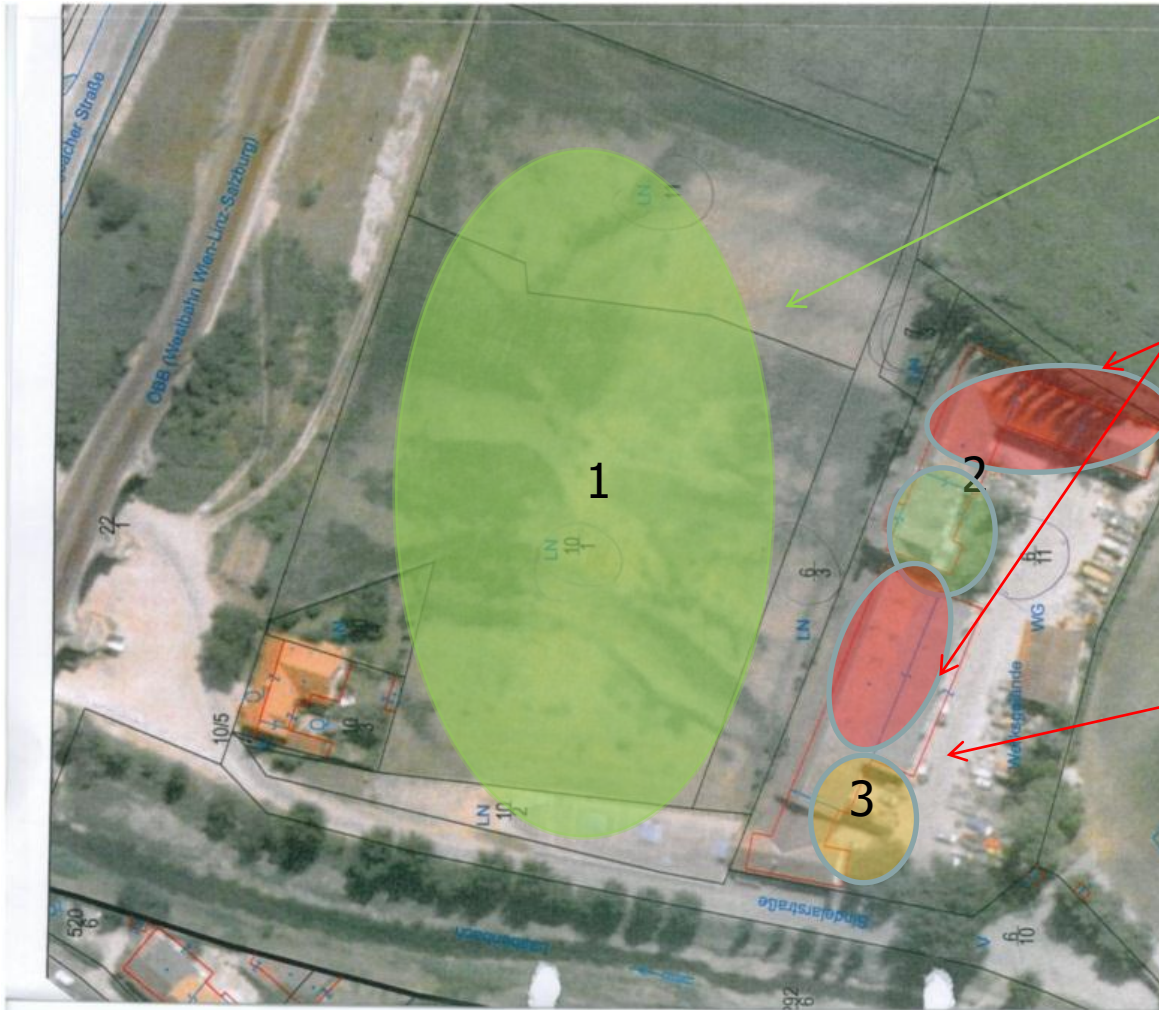
Situation in 2008

March 2008:

1: Dose rate (100-250 nSv/h) and 15-23 Counts. 35 Soil samples for gamma measurement.

2: 6 local and superficial hot spots on concrete and bricks detected. Doserate between 250 -800 nSv/h and 200-800 Counts. Radon measurement devices installed.

3: No Hot spots detected. Slightly elevated dose rates between 160 – 320 nSv/h and 20 – 40 Counts. Radon measurement devices installed.

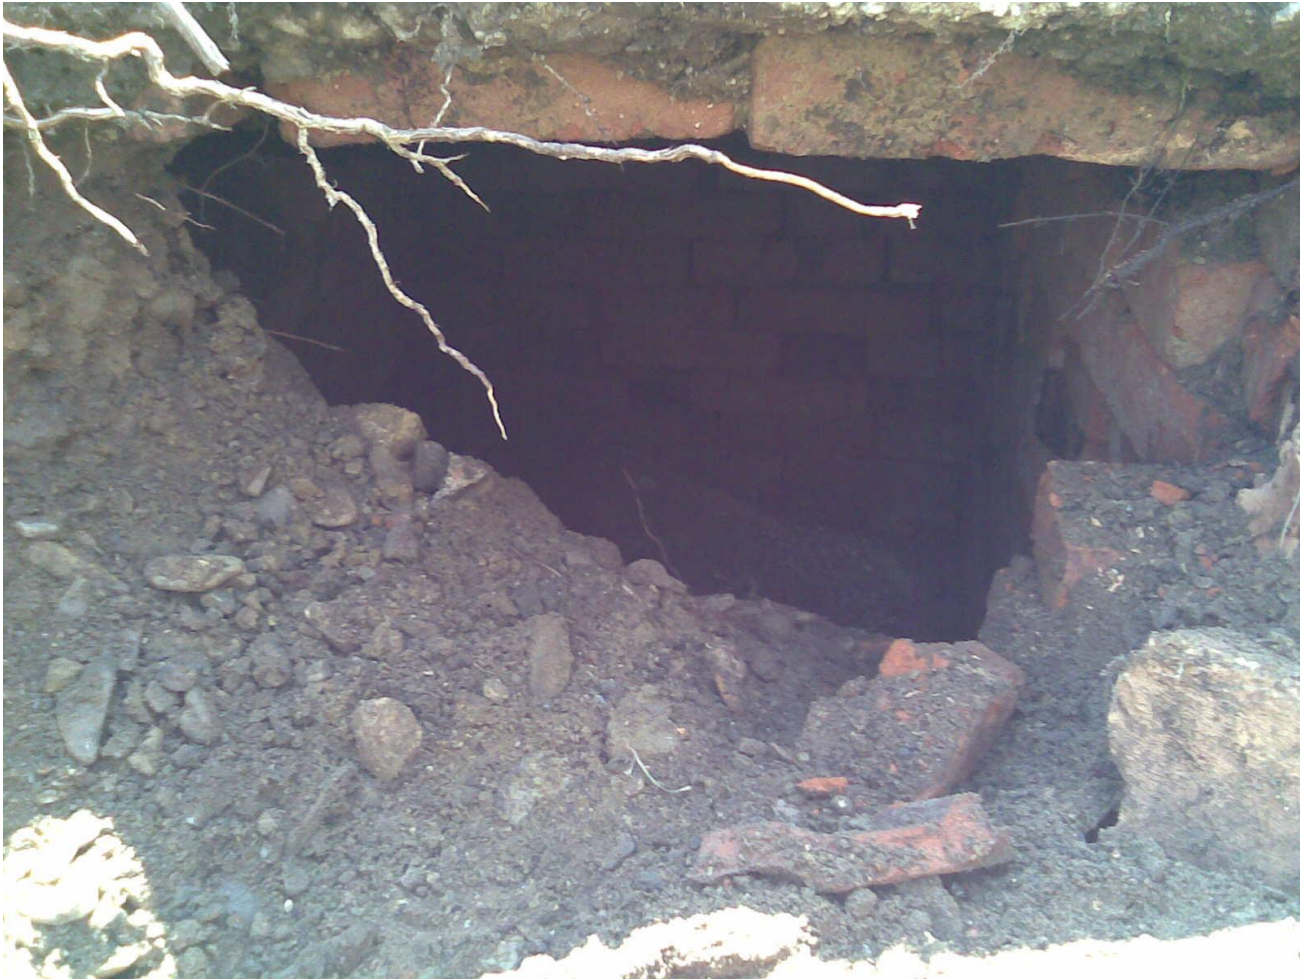
Surprise – something new

- Discovering of unknown parts of former building.
- Foundation stone ceremony in spring 2009.
- International sport event in summer 2009 next to the contaminated zone.
- The nearly-inundation of the pit by the nearby river.
- The positive acceptance of the situation by the local population.
- Discovering of a human skeleton in the last 10 cm of the heavy contaminated zone in the pit.
